Chapter 6 Field Research on the Social and Physical Impact and Responses in the Affected Areas

6.2.3 Initial Damage to Buildings and Physical and Social Infrastructure

6.2.3.1 Building Damage

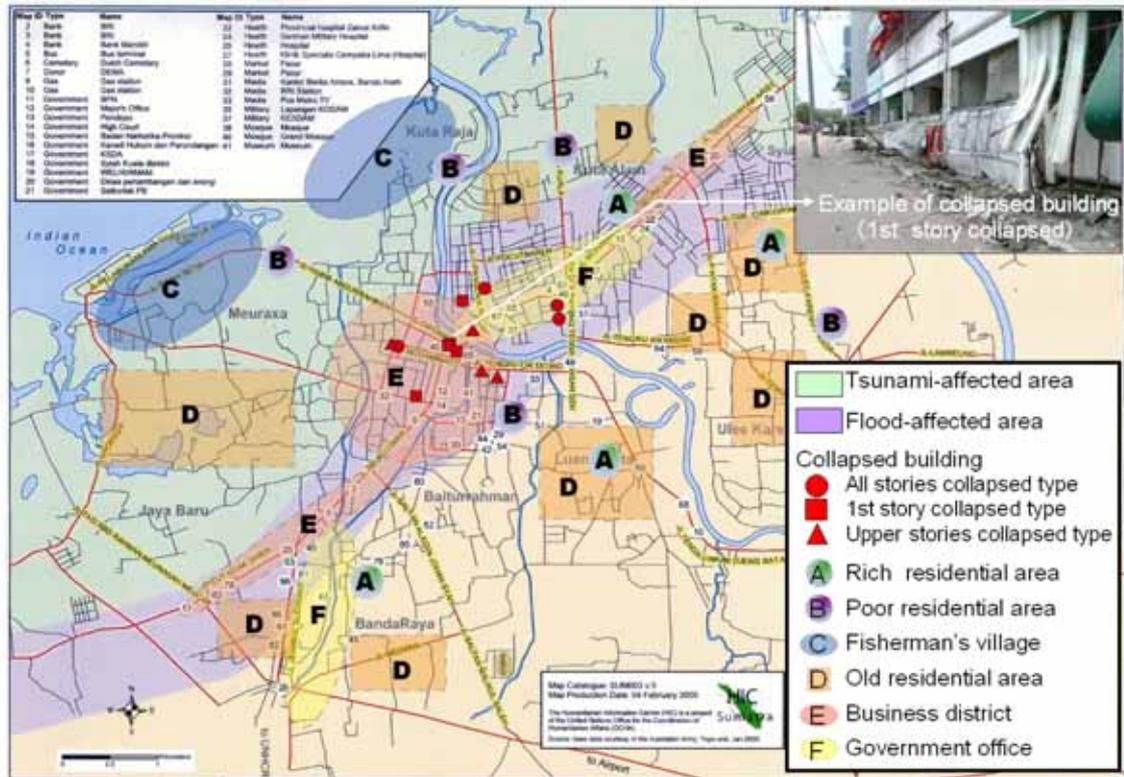
Figure 6.2.1 Distribution of completely collapsed buildings due to seismic ground motion

As for the building collapse process, an interviewed person who stayed inside a collapsed building said: "I was agitated because a slow quake continued for long time. The building collapsed immediately after I ran out of the building". Structures that suffered comparatively large damage other than completely collapsing were towered types such as churches, a tower near the Great Mosque and a water tower. Alternatively it was difficult to identify buildings of lower than two stories that suffered serious damage by seismic ground motion. Therefore it is possible to conceive two influences on the cause of collapse as listed below:

From the result of the above analysis, it was revealed that buildings collapsed due to the earthquake before the arrival of the tsunami. Collapse of buildings may cause failures to escape due to rescue activities for trapped people in the building, and obstacles on the evacuation route. When such buildings are mid- to high-rise, problems of lost evacuation centers may occur. To prepare against tsunami disaster, it is especially important to ensure sufficient seismic performance of buildings and appropriate location for mid- and high-rise buildings which should serve as evacuation centers. In addition, some key issues in the future are to evaluate tsunami force correctly on such important buildings and to establish a design method that takes tsunami load into consideration.

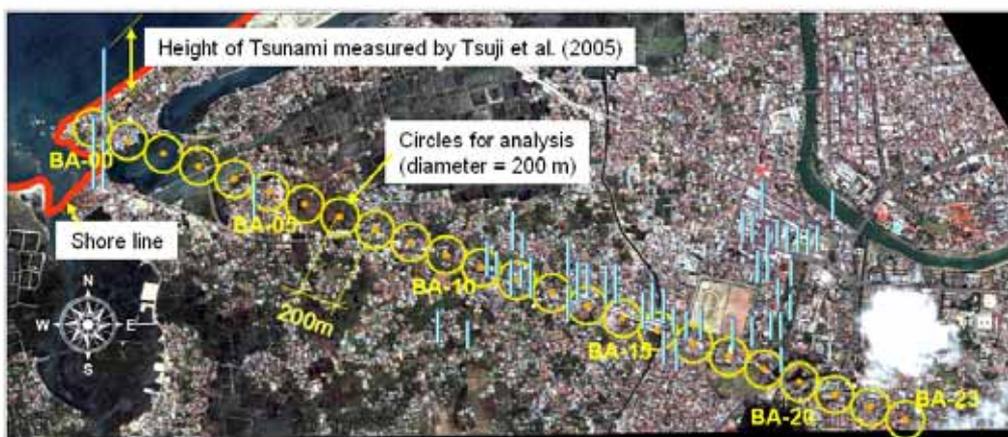
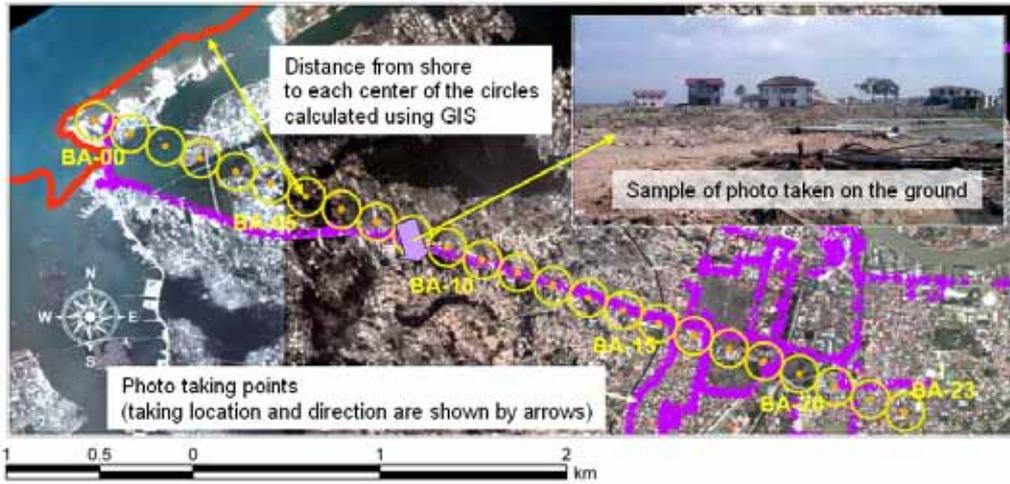
Figure 6.2.2 Study area for building damage due to the tsunami using imagery data

As for building damage caused by the tsunami in Banda Aceh, a distribution of building washout ratio were estimated using satellite imagery data before and after the tsunami and photos taken at the time of the field survey. The satellite imagery data was taken by a high performance observation satellite ("QuickBird" Digital Globe, Inc. US) on June 23, 2004 and December 28, 2004. The satellite imagery data from these two periods and ground photos taken at the time of the field survey were superposed on GIS. Then, the distribution of buildings before and after the tsunami by visual observation was identified. The washout ratio was obtained using following formula (1).

a) Satellite Image by QuickBird (before Earthquake and Tsunami: 06/23/04)

b) Satellite Image by QuickBird (after Earthquake and Tsunami; 12/28/04)

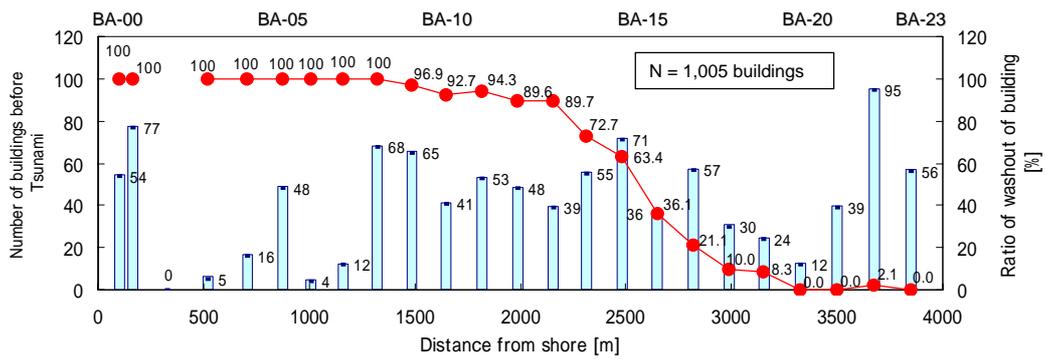
Figure 6.2.3 Relationship between the distance from shore and the washout ratio of buildings due to the tsunami along the analysis line.

Along the analysis line of this survey, tsunami height measurement was performed by Tsuji *et al.*⁴ In the future, the relationship between the tsunami force and building washout rate will be examined.

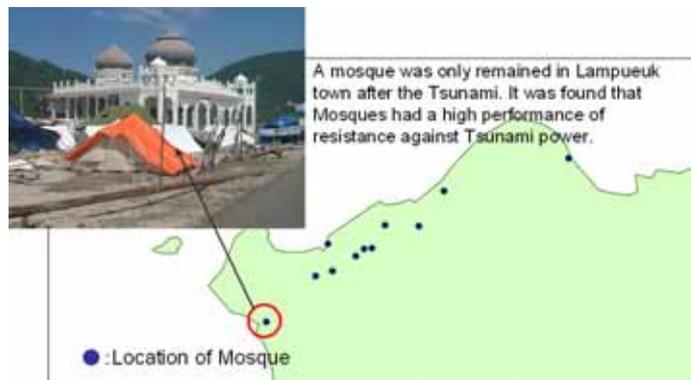
Figure 6.2.4 Distribution of the remaining mosques after the tsunami attack

Many buildings were swept away, while many mosques maintained their original shapes in spite of the completely devastated situation of the surrounding area. Figure 4 shows distribution of the remaining mosques and a sample photo. The reasons why mosques could survive a tsunami were listed as follows: 1) The floor was elevated from the ground and the foundation works were robust. 2) There were few walls and water ran through the mosque smoothly; especially 3) there was no wall attached to the main column, 4) the shape of columns were round, 5) those buildings were constructed carefully, taking about ten years, based on contributions.

Mosques turned out to have great potential for preventing and reducing tsunami damage. Mosques, as the centre of each village in Islamic society, are located throughout the region. Mosques are places where people gather daily for worshipping and for other purposes. It is a common practice for Muslims to take shelter in their mosque when confronting hardship, especially in Aceh where there have long been armed conflicts. Moreover, mosques in Aceh noticeably survived the earthquake and the tsunami with only minor damage.

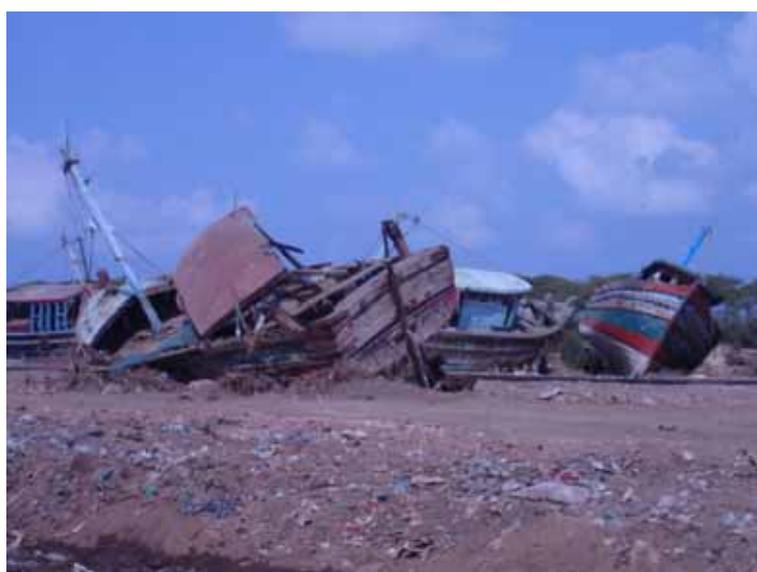
Photo 6.3.1 Damaged Trawlers in Nagapattinam

(1) The worst affected area in Tamilnadu was Nagapattinam District (for the details of the death, see Table 6.3.2), which is known for its religious harmony with the well-known church of Velankanni and the mosque of Nagore. Nagapattinam is a chief port town for anchoring large fishing trawlers, and ships and fishermen's settlements were badly damaged there (Photo 6.3.1).

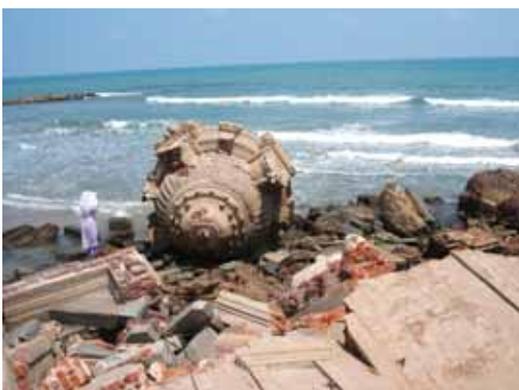
Photo 6.3.6 Masilamaninathar Temple, Tarangambadi

The 14th century Masilamaninathar Temple (built by Maravarma Kulasekara Pandiyan in 1305) just north of the fort had been already substantially destroyed by seasonal cyclones, but the damage done by this tsunami was less than estimated (Photo 6.3.6).
